U. S. S. ERIE (PG50)

TORPEDOING AND LOSS

25, September, 1943

WAR DAMAGE REPORT No. 31

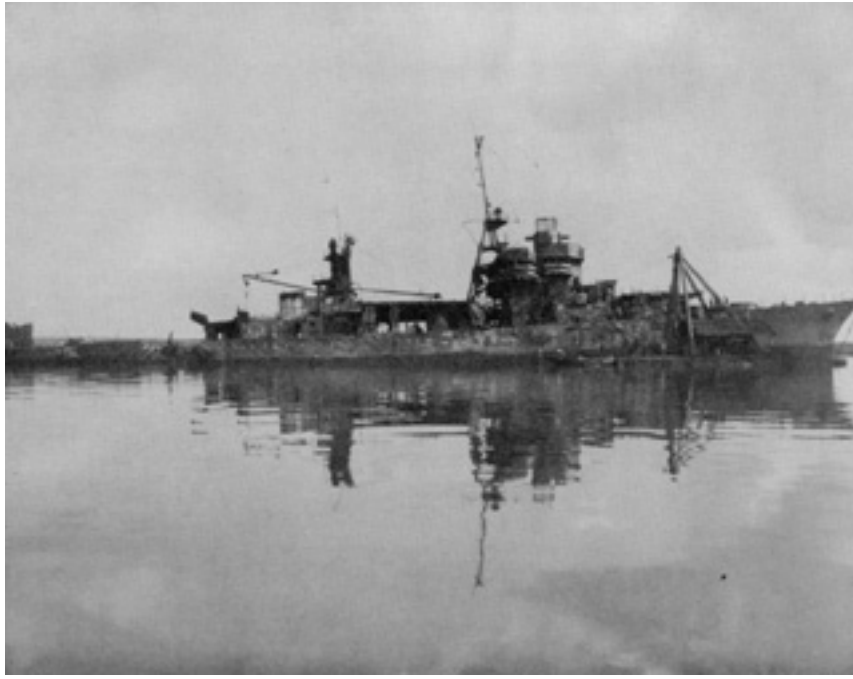
30. No change in the position of the stern section relative to the forward section was noted during the interval of 28 November to 4 December inclusive, although the stern section had been observed to be working slightly. After the hull had assumed its starboard list on the morning of 5 December, it was observed that the stern section was not in its previous position relative to the forward section. The deck line of the stern section was observed to be more nearly in alignment with the deck line of the forward section. At this point it was also observed that the Spanish windlass hung slack. As the vessel passed the upright position, when listing to port, it was observed that the stern section, still buoyant, was such as to indicate that a pronounced change of trim by the stern of the forward section had occurred. The stern section evidently remained attached to the remainder of the hull inasmuch as it too capsized.

Photo 1: USS ERIE - Willemstad Harbor, 2 December, 1942 - starboard side. Salvage operations in progress. Note sag of stern.

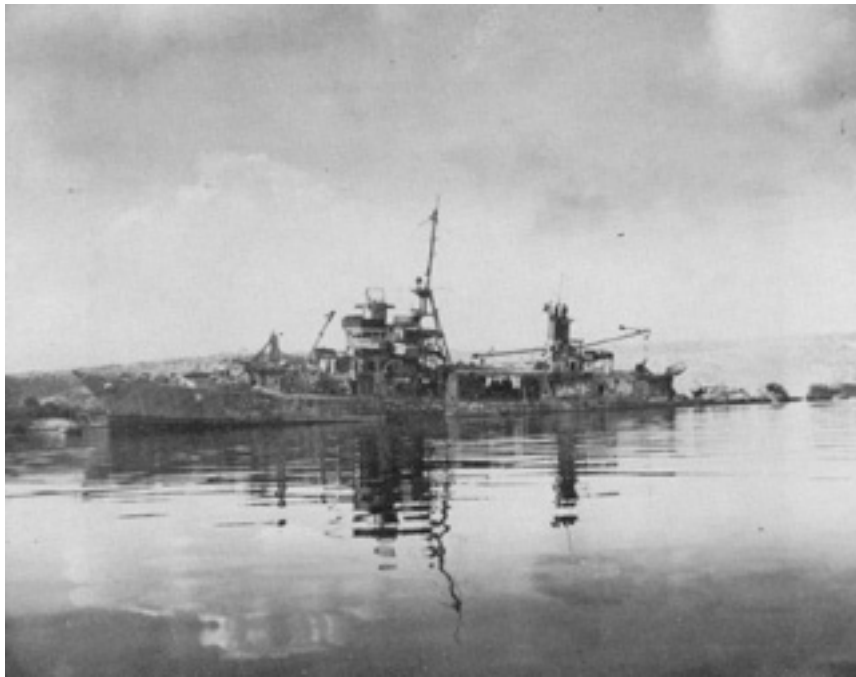
Photo 2: USS ERIE - Willemstad Harbor, 2 December 1942 - port side.

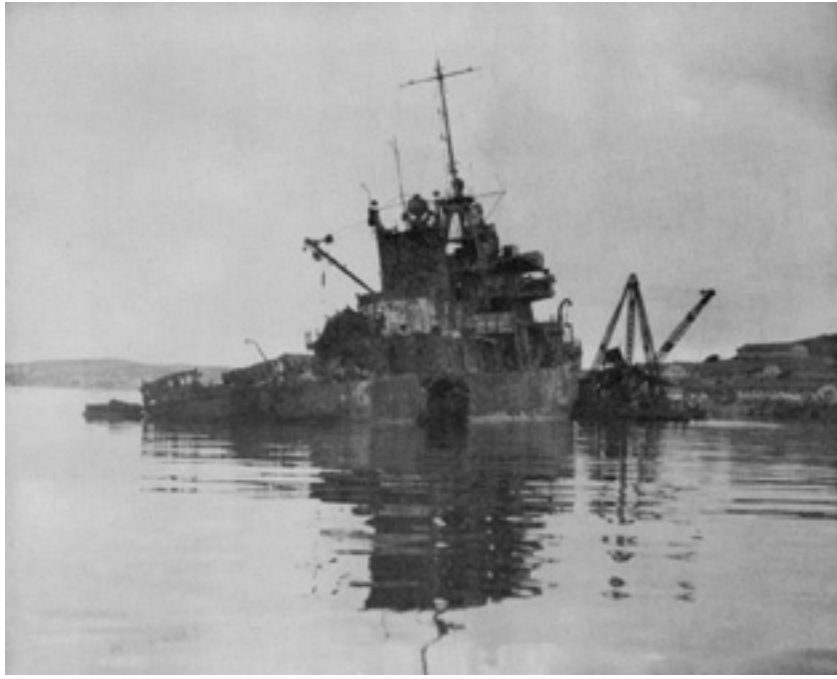
Photo 3: USS ERIE - Willemstad Harbor, 2 December, 1942 - starboard quarter.

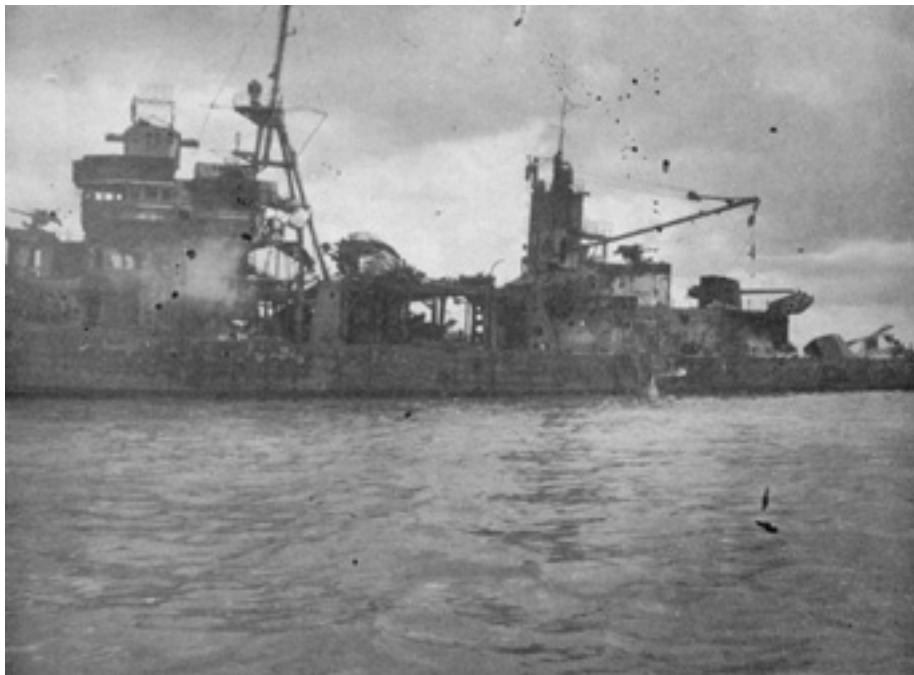
23. Some time during the two-day interval, the two aircraft depth bombs and the two 100-pound G.P. bombs exploded. These were in the ready service stowage located approximately at frame 72 on the airplane deck slightly to starboard of the stack. The stack was knocked down and badly damaged; large holes were blown in the airplane and main decks; the second deck, of 50 lb. S.T.S. plating, was deflected slightly downward and the starboard leg of the mast demolished. The forward bridge structures also received extensive fragment damage.

Photo 4: USS ERIE - Beached. About 18 November, 1942. Note remains of stack.

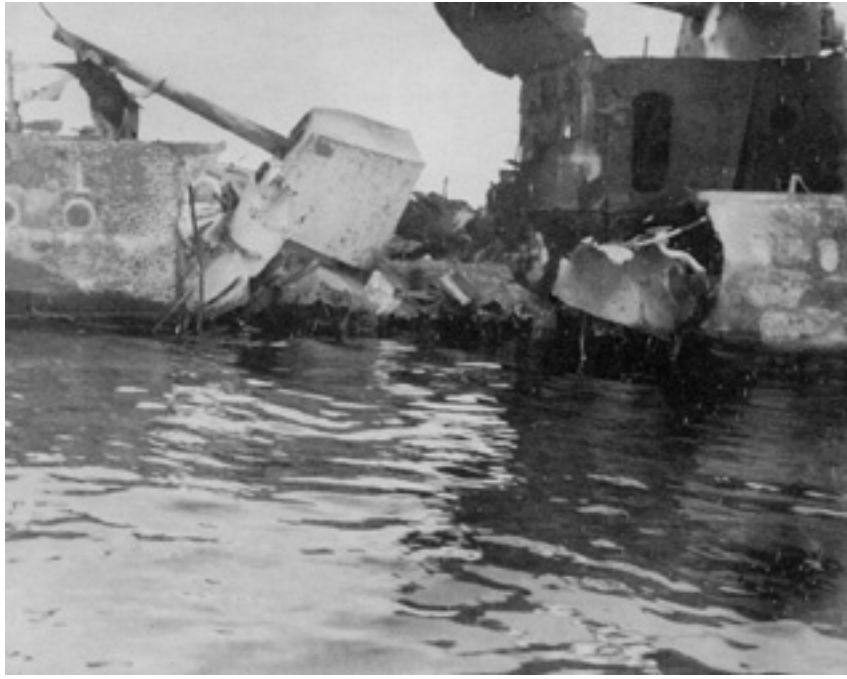
14. At 1733 ERIE was struck by a torpedo from a submerged submarine. The torpedo struck and exploded on the starboard quarter about frame 126 (abreast the after 6" gun) and about five feet below the waterline. The hull below the waterline was ruptured for a length of about 45 feet. The break extended vertically from five feet above the keel, on the starboard side, up to the main deck and across the main deck almost to the port side. The platform and second decks were both ruptured in way of the torpedo explosion. The after 6" gun foundations were demolished and the mount fell vertically several feet. On the second deck all bulkheads between bulkheads 107 and 141 were torn and ripped. The watertight door in bulkhead 107 was distorted and could not be closed. Fuel oil tanks, the diesel oil tank and the gasoline compartment, all in way of the explosion, were largely demolished and oil and gasoline were spread throughout the second deck coincident with the flooding of the area between bulkheads 99 and 141.

32. It is known that both German and Italian submarines ordinarily use torpedoes which have a warhead charge of about 660 pounds.* The shallow depth, estimated as five feet, at which the torpedo struck the hull probably accounts for the fact that underwater damage was somewhat less than would normally be expected to result from a 660 pound explosive charge. Topside damage was comparatively more extensive than would occur from a deeper running torpedo.

Photo 5: USS ERIE - Beached. Torpedo Damage, starboard quarter.

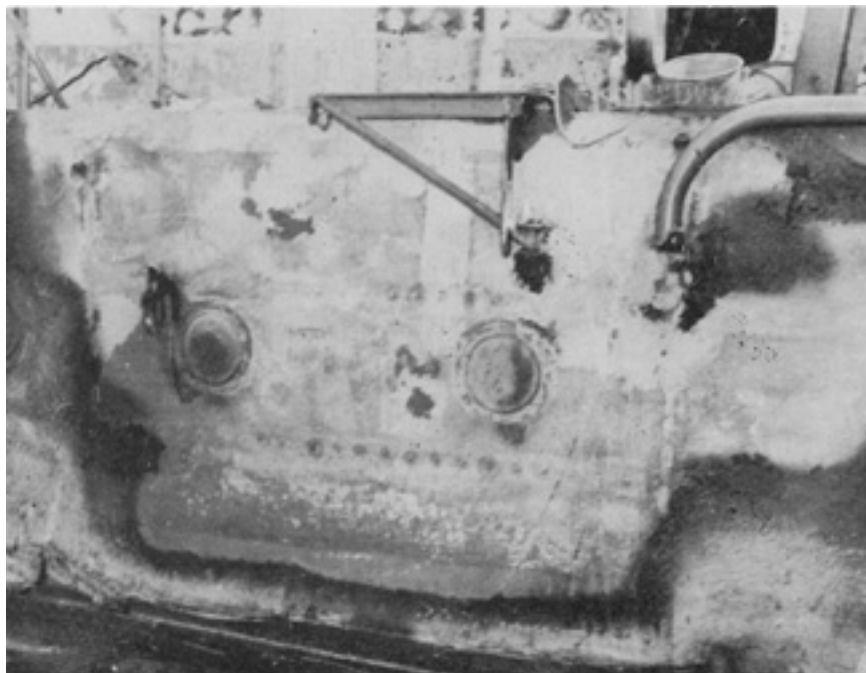
38. The fire, spreading up and forward, soon reached the vicinity of the ready service room for No. 4 6" gun. Twelve minutes after the torpedo explosion the 6" powder charges started exploding. Ten minutes later the projectiles began detonating. The heat from the fire literally roasted the ammunition. The powder charges in No. 3 ready service room were removed and placed on deck before the fire reached the stowage. After ERIE was reboarded, projectile fragment holes were found in the vicinity of all the 6" ready rooms as noted on Plate I and shown on Photos 6, 7 and 9. There was no evidence of mass explosions or detonations. This behavior of projectiles and powder charges is consistent with other battle experience and tests made by the Bureau of Ordnance.

Photo 6: USS ERIE - Port shell, frames 110-115. Note 6" projectile hole caused by projectile from No. 4 gun ready service room.

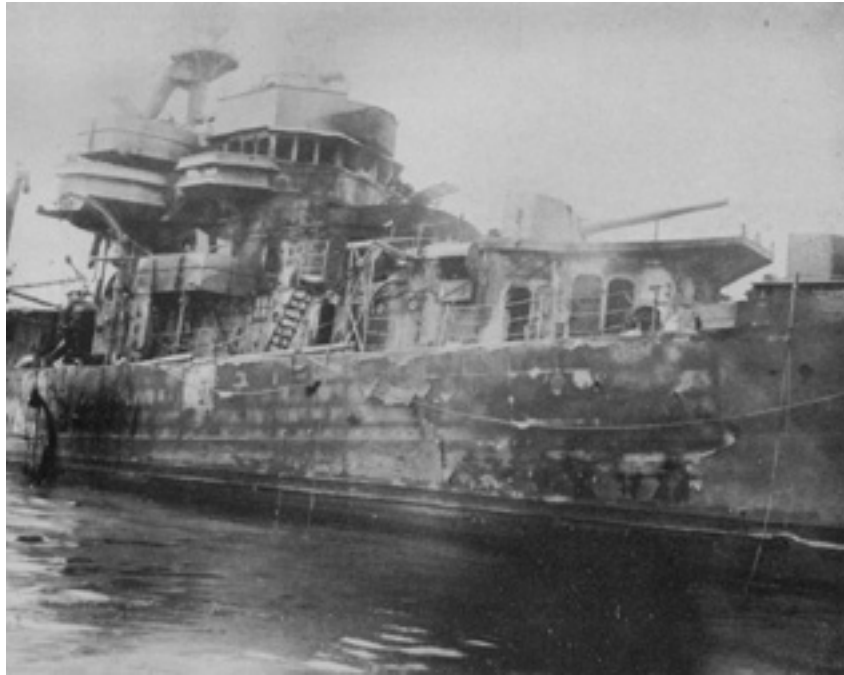
Photo 7: USS ERIE - Starboard shell, frame 15 looking aft. Note 6" projectile holes caused by projectile from No. 1 gun ready service.

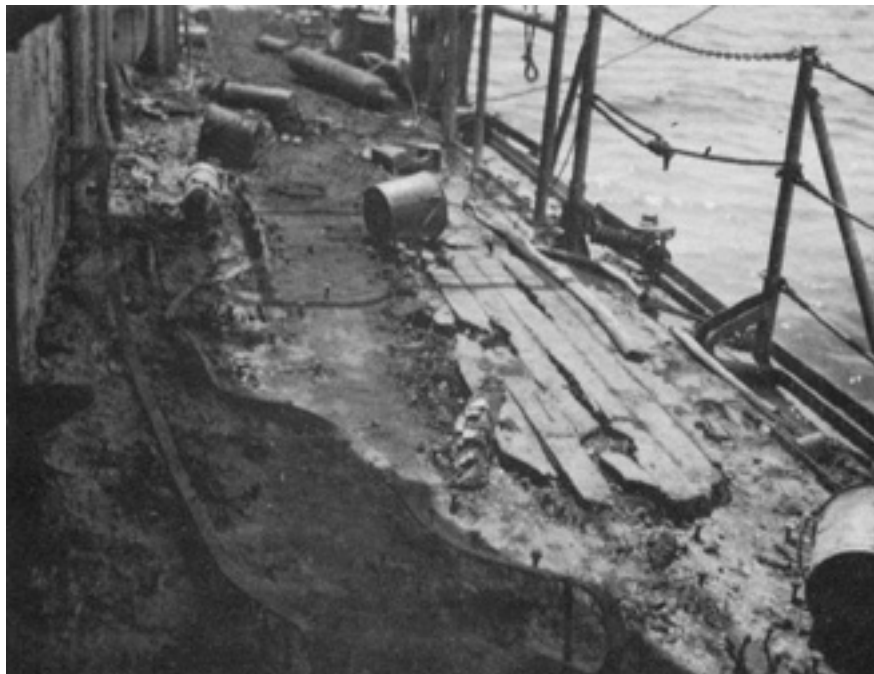
42. The Commanding Officer, in reference (a), extensively described and discussed the fire. He noted that linoleum-covered decks were badly warped, bulkheads were buckled, aluminum lockers and their contents consumed and wooden decks burned. Evidence of the intense heat generated is apparent in photos 1-3, 8 and 9. He particularly emphasized the hazard of paint on both interior and exterior surfaces. This is one of the few cases which have come to the attention of the Bureau where it is clearly evident that large quantities of paint were actually consumed by fire. Ordinarily paint is charred and blistered. Photo 8 is also the first positive evidence received that a wooden deck has been consumed by fire. Wooden decks frequently are charred, however. From all the evidence and the references, the fire which gutted ERIE appears to have been an unusually intense general conflagration to which practically everything aboard contributed.

Photo 8: USS ERIE - Main deck abreast after deck house. Note that wood deck has burned.

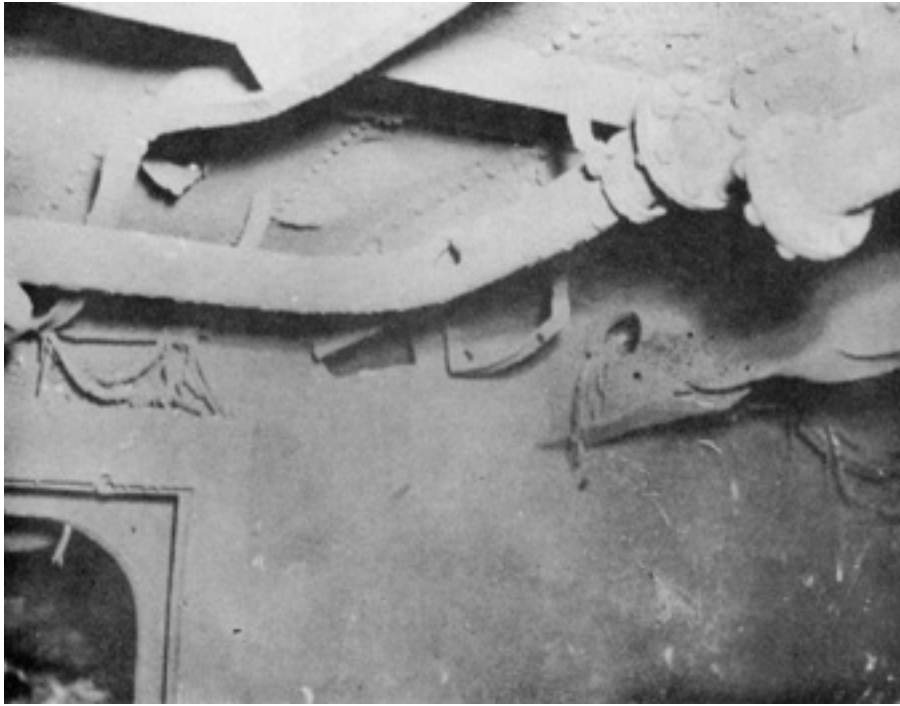
Photo 9: USS ERIE - Compartment D-202-1L looking forward to bulkhead 107. Note fragment hole in bulkhead and 4" fire main. Note that composition valve body has melted away. The valve gate and stem were found on deck underneath.
