## ROUTINE MAINTENANCE MISHAPS “DECK DRAIN H<sub>2</sub>S DANGERS”

This will show you how maintenance to piping systems can go wrong and the Lessons Learned by these incidents

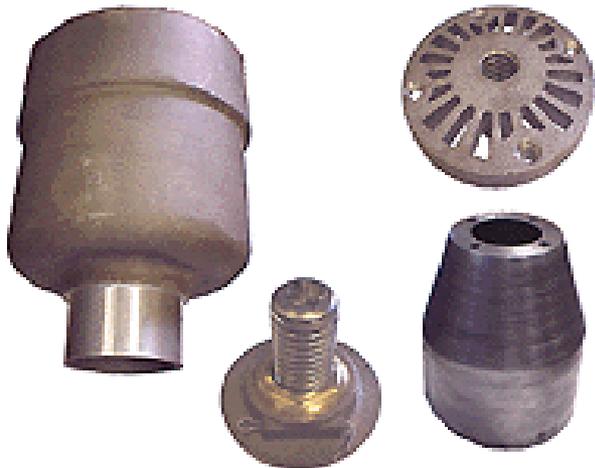
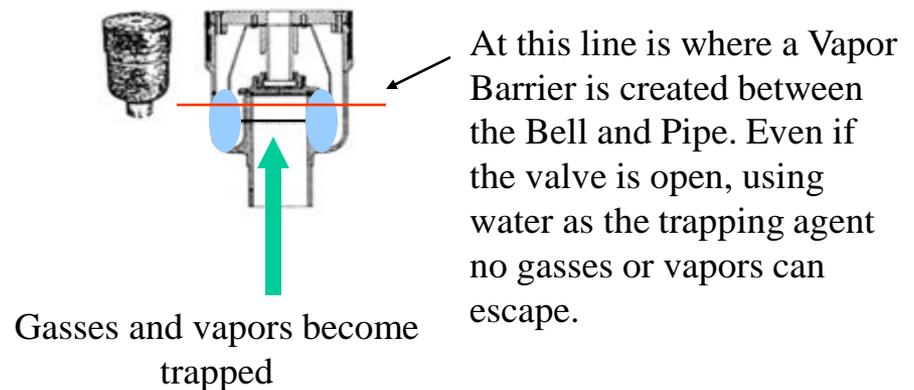
- A request for assistance was submitted due to a smell coming from the deck drains in the scullery and surrounding area.
- The drains were found to be missing vital pieces to the drain assembly. The bell on one drain in the passageway and the whole strainer, bell and valve assembly to the one in the scullery.
- The bell allows the drain to make a vapor barrier between the pipe and the strainer. It creates this barrier using water the same as a peat trap utilizes in a urinal.

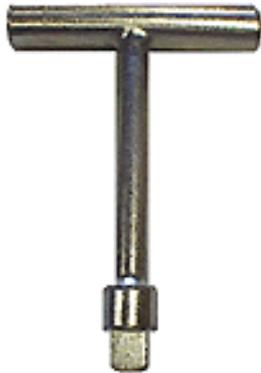
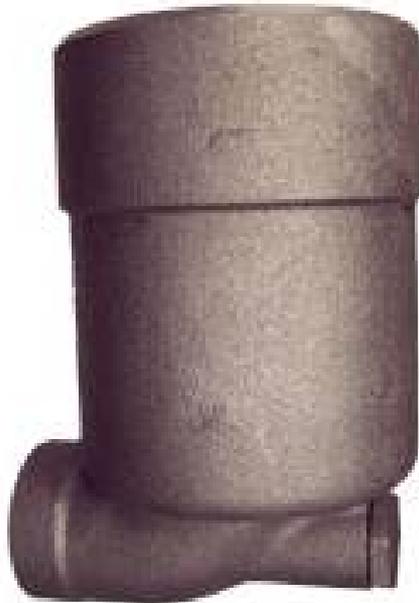
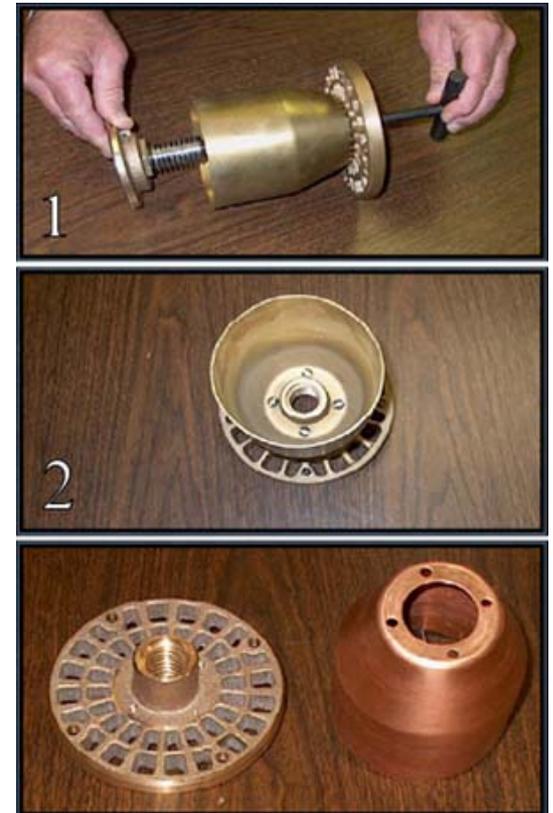
- The next drain to investigate was in the scullery.
- The deck drain was located within the sump which sits between the dishwasher and the garbage grinder.
- The deck drain had the strainer installed but with no bell.
- Three pipes were routed to the drain with each having a union attached to allow maintenance to the deck drain.
- During removal of the unions the ship took a roll and a “wind” was released from the drain assembly.
- This caused the repairman to become incapacitated by a large amount of H<sub>2</sub>S gas. Scullery workers assisted the sailor to a fresh air environment and contacted the Corpsman.
- The deck drain was tested with a gas analyzer and found to be reading 27 PPM H<sub>2</sub>S (almost 3 times PEL).

- The scullery was evacuated and ventilated.
- The repairman suffered no long-term effect and returned to full duty with no lost work days.
